Analysis and Comparison of Used and New Lead Window Comes

MMR Project No. 0463-21-1

February 11, 2005

From
Massachusetts Materials Research, Inc.

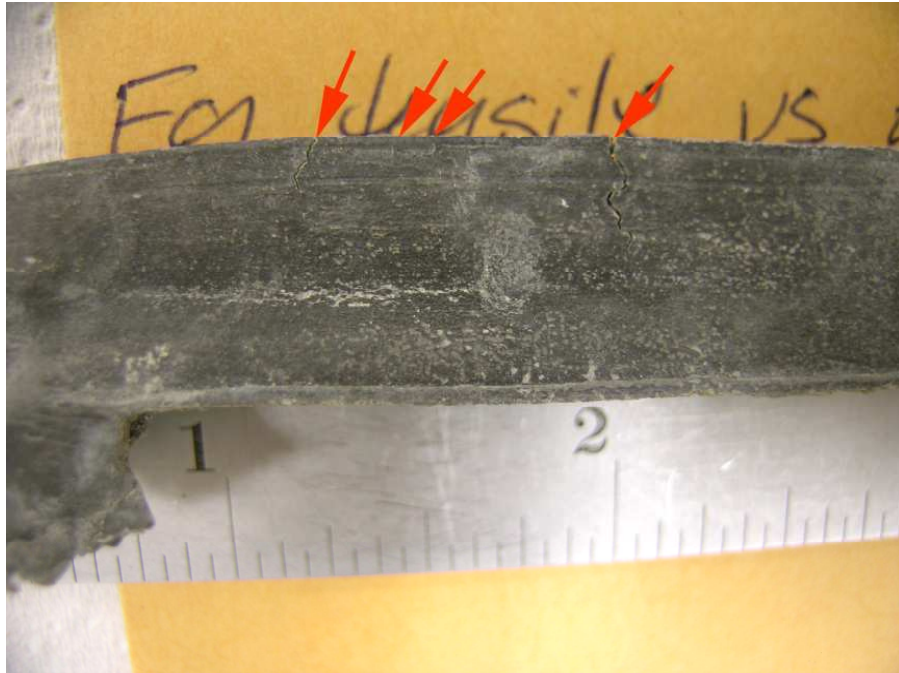
Visual examination of the older comes revealed a multitude of fine cracks extending into the came from its outer edges. Figure 1 shows several of these cracks along a one-inch length of Sample A. The older joints revealed widespread cracking as well. Figures 2 and 3 show joint cracks in Sample A window joints. The crack in the lower joint shown in Figure 2 was later examined with EDS analysis. For comparison, Sample E, a new joint with new comes is shown in Figure 4. Visible cracks were common to all older samples and not present on new samples. Since the cracking visible with the naked eye is not necessarily the only cracking present, further microscopic examination was performed.

Figure 1: Cracks in Sample A as-received, arrows.

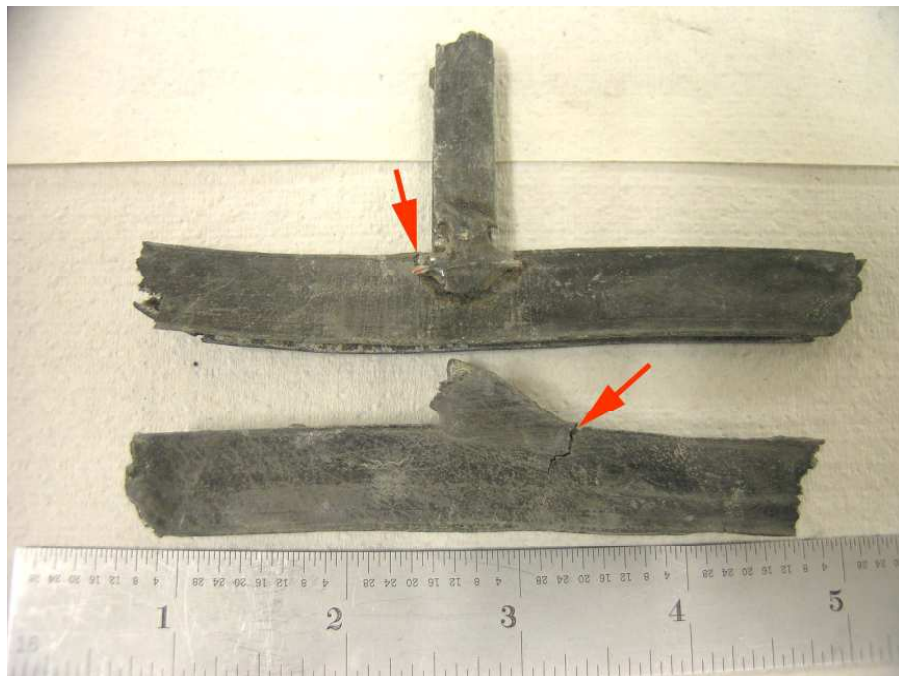
Figure 2: Cracks in Sample A joints, as-received, arrows.

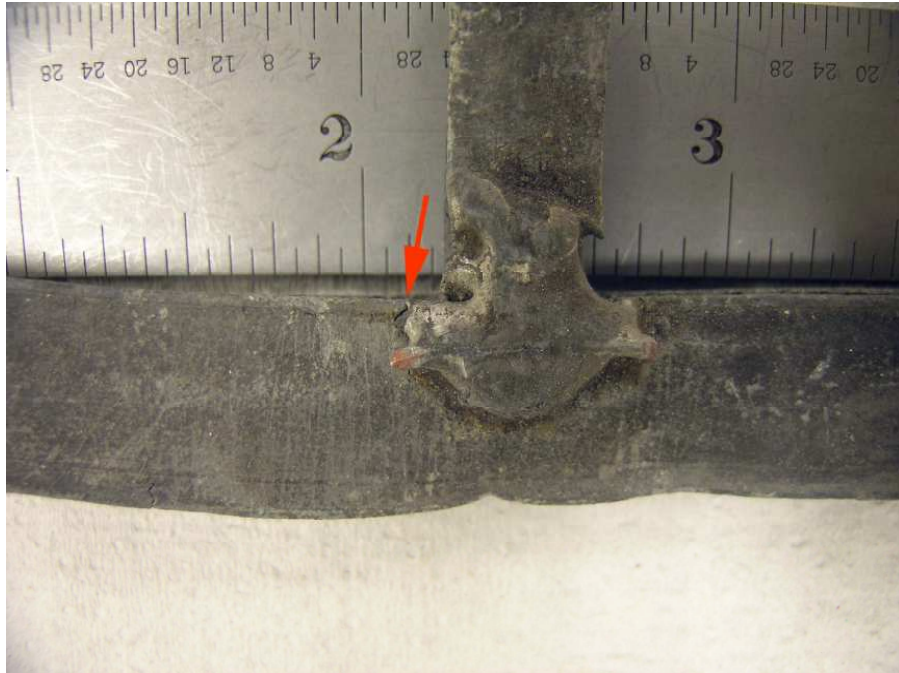
As Figure 3 shows, cracking at resoldered joints is a concern. In addition to the crack, note the jagged come form and melt-through regions at this T-joint. These are all hallmarks of a poor resoldering. The melt-through and jagged eaten-away appearance of the come results from too high heat and/or too long a contact between the soldering tool and the come in these regions. All the stress raiser issues previously discussed regarding uneven geometry are illustrated here. Cracks in the weld toe region, common in the samples examined here from different windows, are the result of the metal attempting to accommodate strains induced by the soldering. This can be due to excessive heat application, entrapped flux, creation of brittle intermetallic compounds, or poor stress distribution elsewhere along the come due to other repair work.

The prominence of such cracks in the samples examined from different sources suggests that they are less the result of the skill level of the person resoldering the joint (although the overall quality of the Figure 3 joint is very low) than of the difficulty in properly cleaning and designing a repair joint when the approach is to resolder and call it good.

Figure 3: Close-up of crack in top joint of Figure 2, arrow. Note also joint profile and appearance.

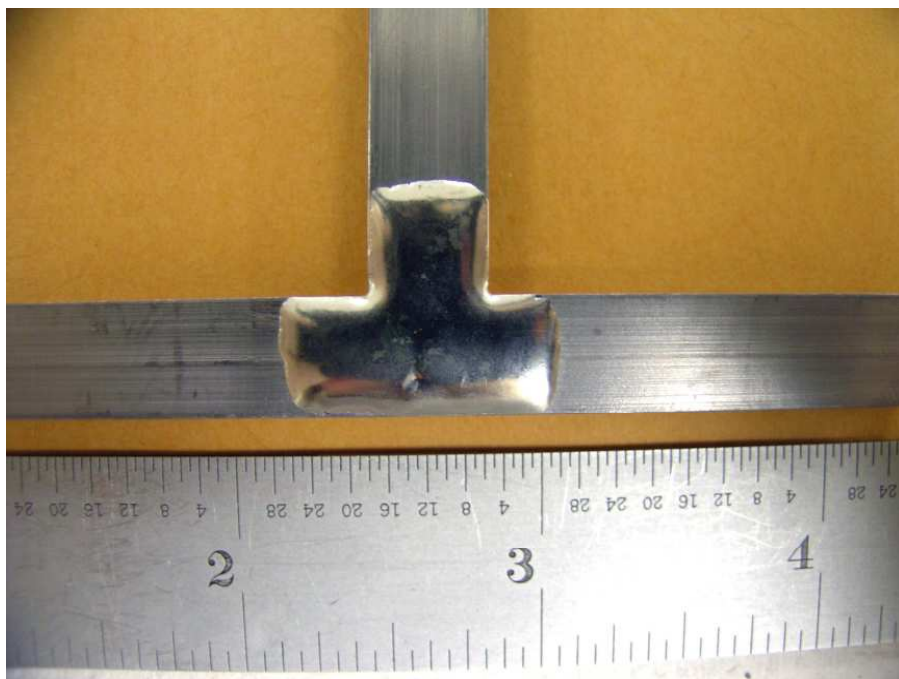
Figure 4: New joint.

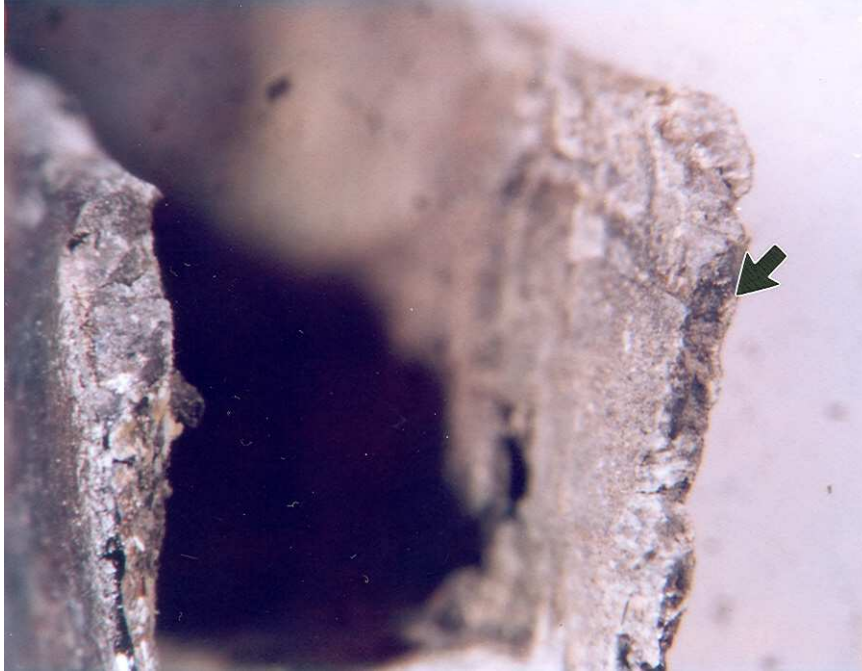
Figures 5 and 6 show the fracture surfaces of cracks in the came Samples A and B, respectively. Both photographs were taken with the same settings under the same lighting conditions within minutes of each other. Note that the fracture surface of the Sample A crack is noticeably darker than that of the Sample B crack. A portion of the laboratory-created fracture is visible in Figure 6. This laboratory-created crack is knife-edged and shiny. Contrast this bright, shiny appearance with the older fracture surfaces. The darker fracture surfaces are likely the result of greater oxidation. To verify that greater oxidation is the cause of the difference in appearance, these fracture surfaces were examined in a scanning electron microscope.

Figure 5: Fracture surface of Sample A, arrow. Mag. 12X

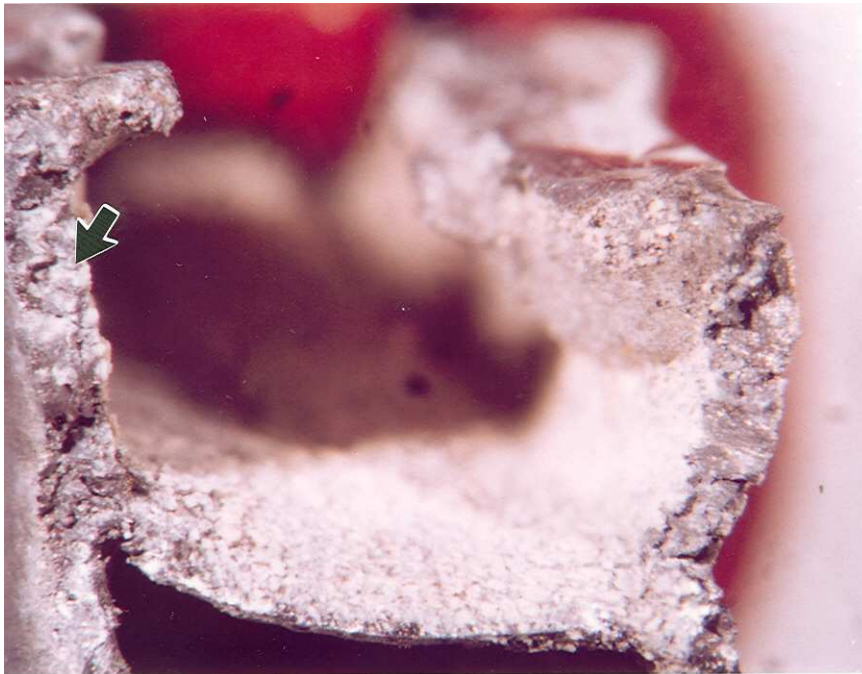
Figure 6: Fracture surface of Sample B, arrow. Mag. 12X

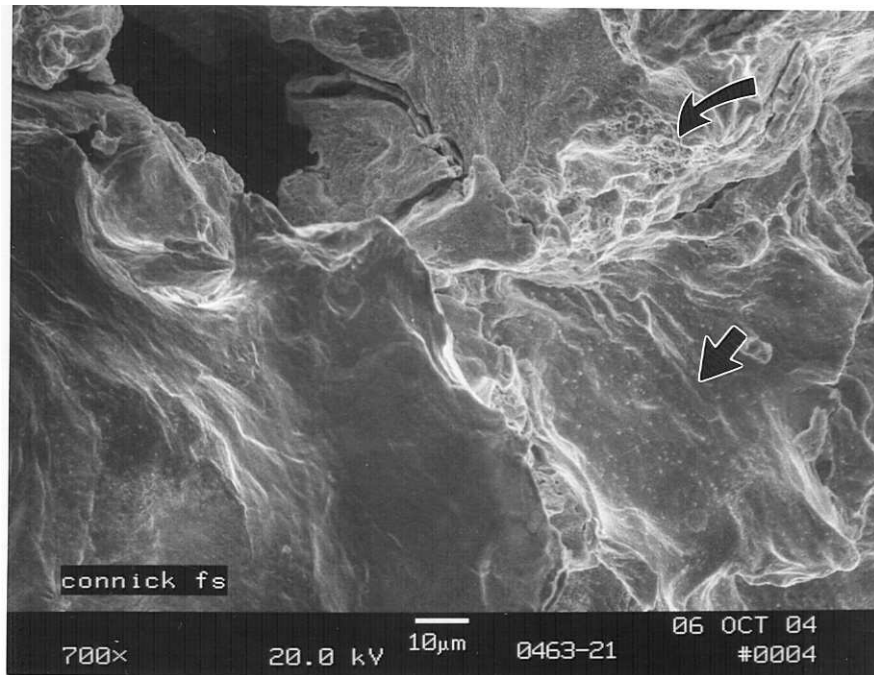
The surfaces of the cracks shown in Figures 5 and 6 were examined in both the as-received and cleaned conditions. The oxide layer present on both surfaces obscured the fracture features in the as-received condition, so a light cleaning solution of a substance known as Alconox was used to remove it. After cleaning, both fracture surfaces exhibited ductile dimple rupture fracture mode with extensive stretching and tearing, Figure 7. This indicates a very ductile, or deformable, metal. This is the same fracture mode that most ductile metals exhibit under tensile testing except that the test specimens typically lack the tearing features. It represents exposure of the metal to a force beyond its physical capabilities to withstand. Such tearing could occur from unusually high wind gusts, undersized comes, lead creep, out-of-alignment panes, or the weight of the glass over time.

Figure 7: Sample A, ~ 1913, fracture in SEM showing ductile dimple rupture, curved arrow, and wide patches of ductile tearing, straight arrow. Mag. 700X

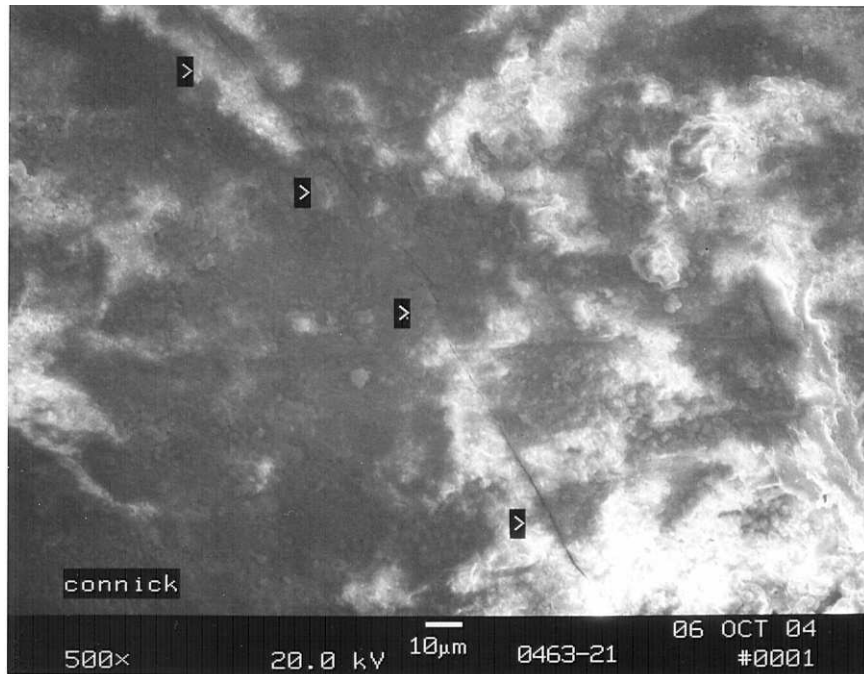
The flat surfaces of the Sample A came were also examined to check for cracks not visible to the naked eye. Several randomly-selected regions were examined and approximately one third of them possessed a crack. Several of these cracks are shown in Figures 8 through 10. Note that the magnifications in figures range from 50X to 500X. None of these cracks was visible to the naked eye and only one was visible at 15X (shown in Figure 10 at 50X for greater clarity). Figure 11 shows the region where the crack pictured in Figure 8 was located. Note that it is not visible at 15X. This means that any repairs carried out on visible cracks leave a multitude of cracks untouched and unremedied.

Figure 8: Cracking on flat surface of Sample A, arrows, proceeds into lead beyond oxide. Mag. 500X

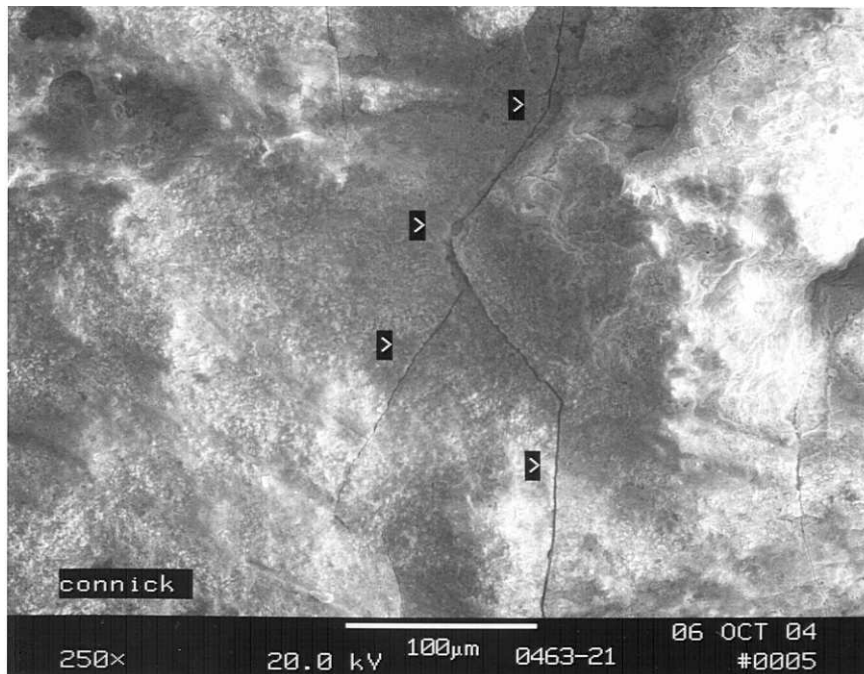
Figure 9: Cracking on flat surface of Sample A, arrows, proceeds into lead beyond oxide. Mag. 250X

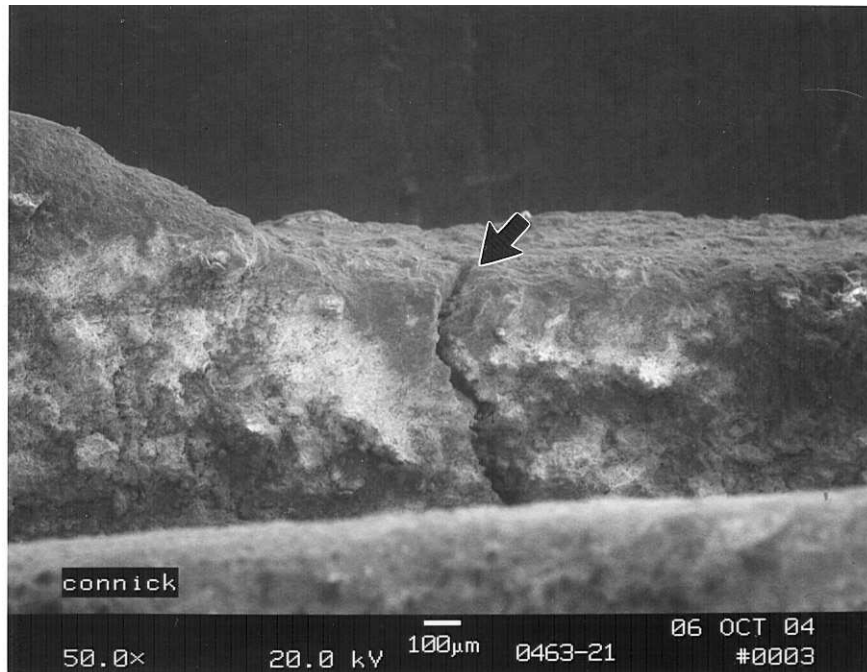
Figure 10: Crack in came near solder, Sample A, arrow. Mag. 50X

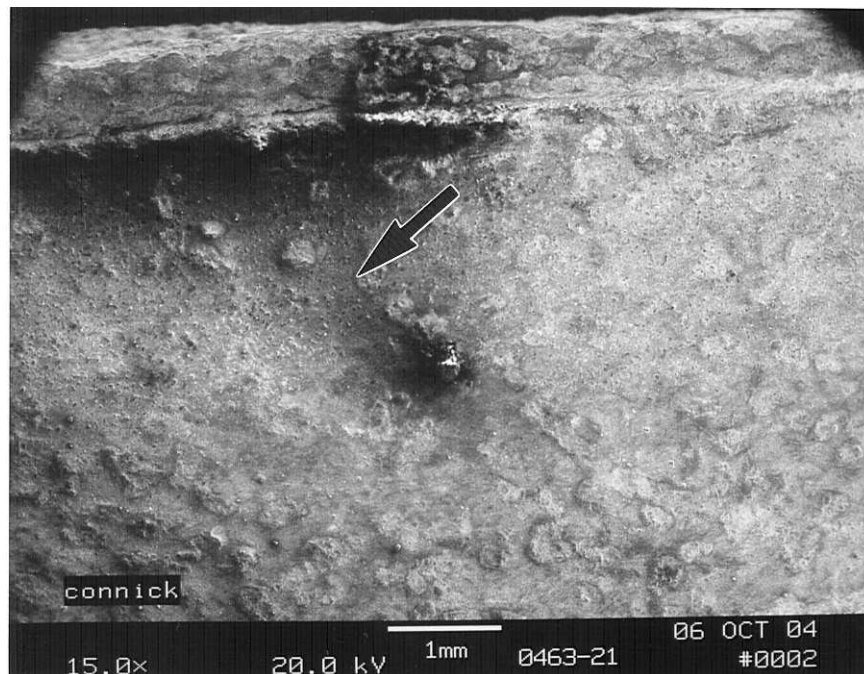
Figure 11: Location of cracks on Sample A came, arrow. Mag. 15X

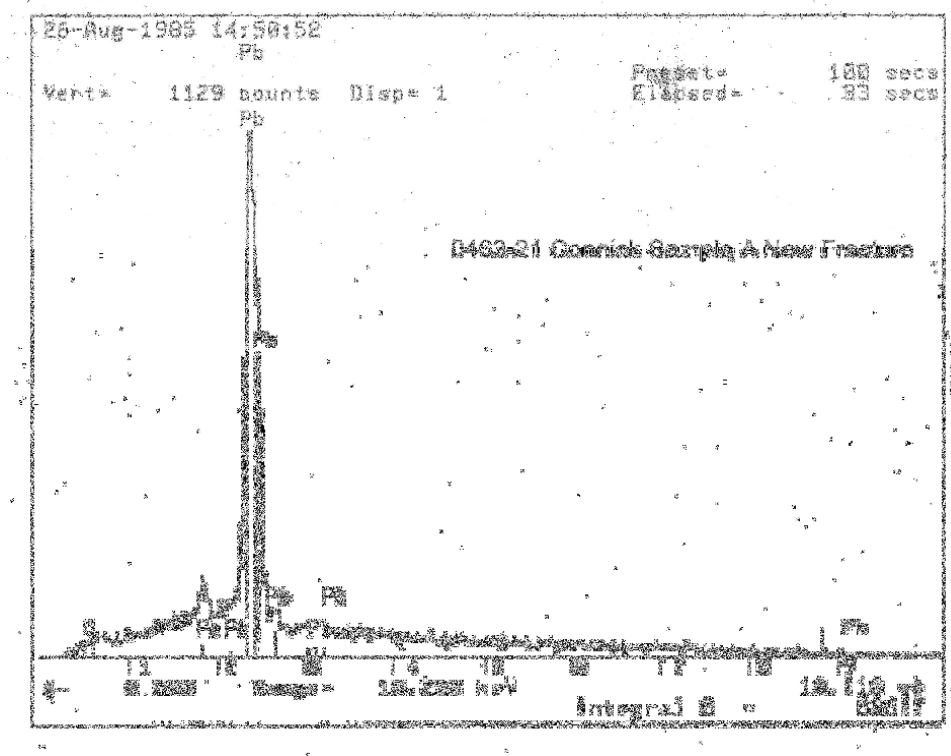
Figures 12 and 13 are the spectrograms for Sample A old fracture (present upon sample receipt) and new fracture (laboratory created). The difference in oxygen levels is readily apparent with the old fracture possessing an oxygen peak approximately three times as high as the laboratory created fracture.

Figure 12: Sample A old fracture EDS spectrogram.

Figure 13: Sample A new fracture EDS spectrogram.

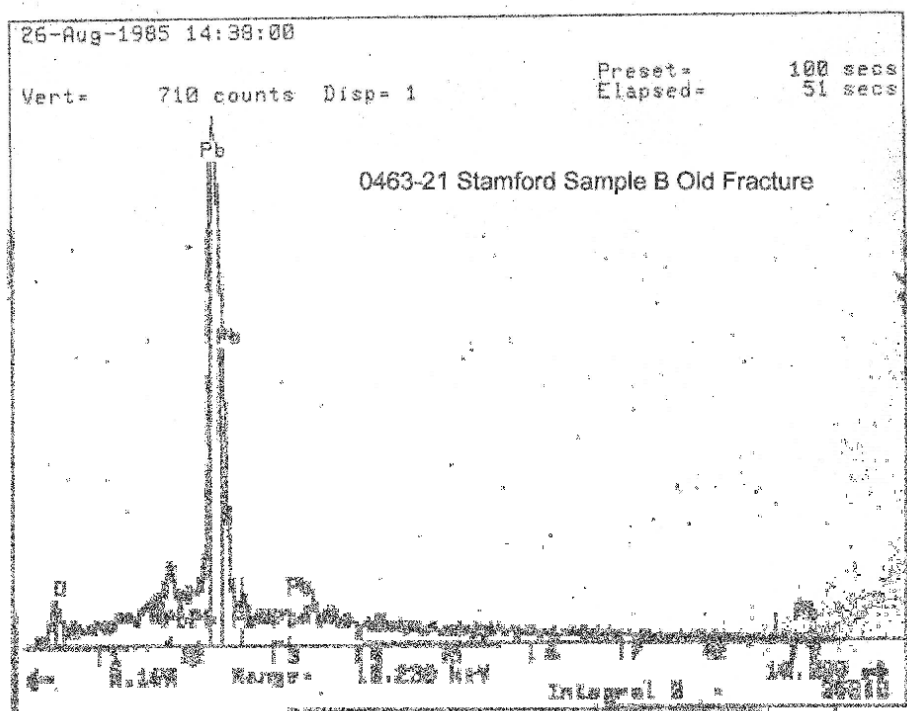
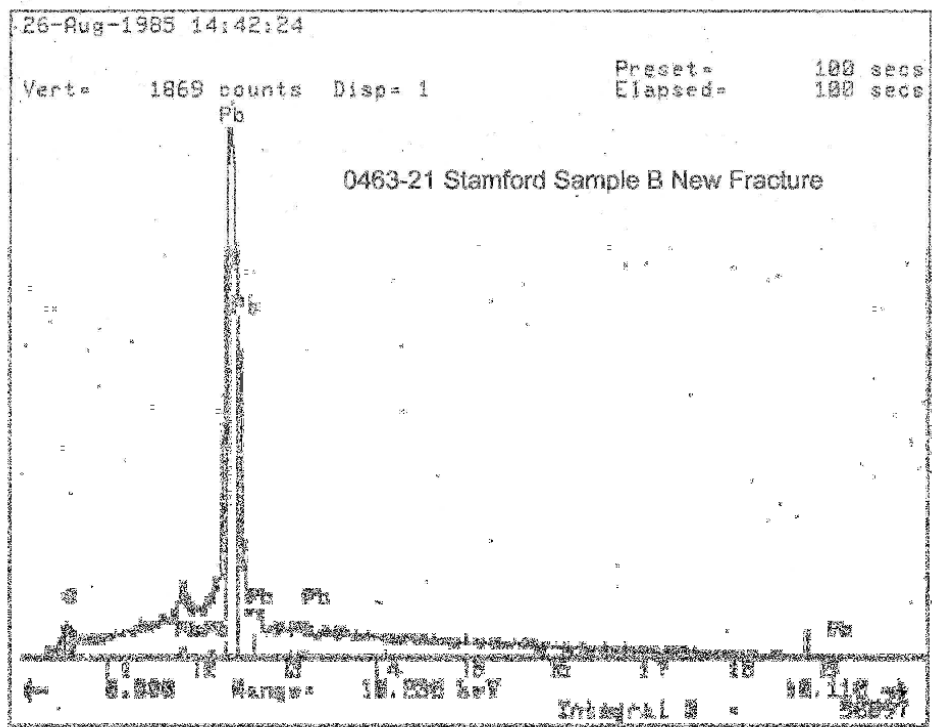
The difference is a little less striking in Figures 14 and 15, which show the old and laboratory-created fracture oxygen levels of Sample B. The old fracture oxygen peak is approximately half again as high as the new fracture peak. Recall that Sample B is younger than Sample A, so age-related cracking would likely occur later in Sample B, assuming similarity of stresses and environment. This translates into less oxidation time for the Sample B crack than for the Sample A crack.

Figure 14: Sample B old fracture EDS spectrogram.

Figure 15: Sample B new fracture EDS spectrogram.

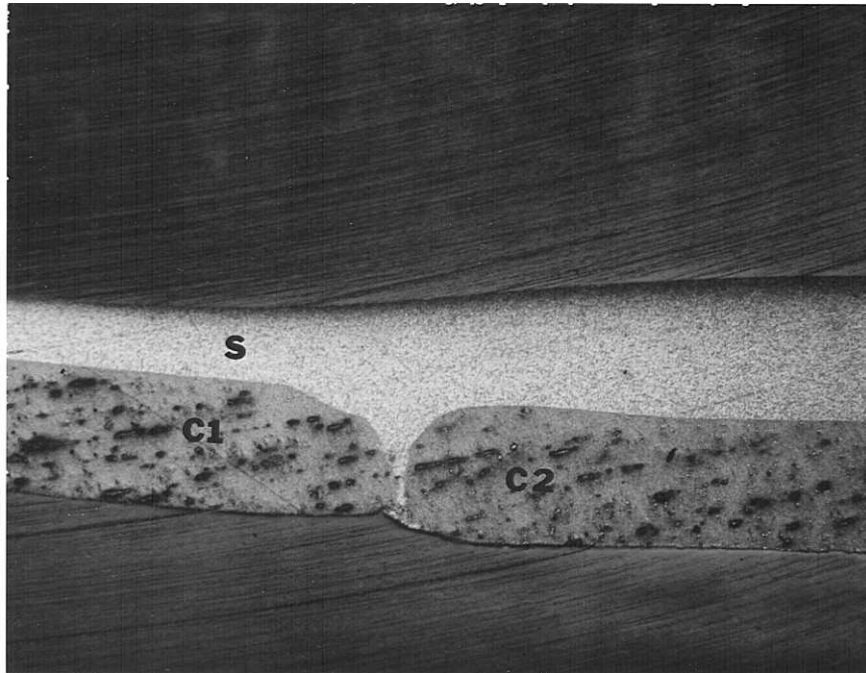
Figure 16 shows a new solder joint, Sample E, created for comparison. The comes joined by the solder are marked "C1" and "C2", and the solder is marked with an "S". Note that there are no gaps between the comes and the solder and the solder is solid with no inclusions (i.e. foreign particles), cracks, porosity (i.e. holes), or regions with lack of fusion. This was consistent along the entire joint.

Figure 16: New solder (S) joint joining two comes (C1 and C2). As-polished.
Mag. 25X

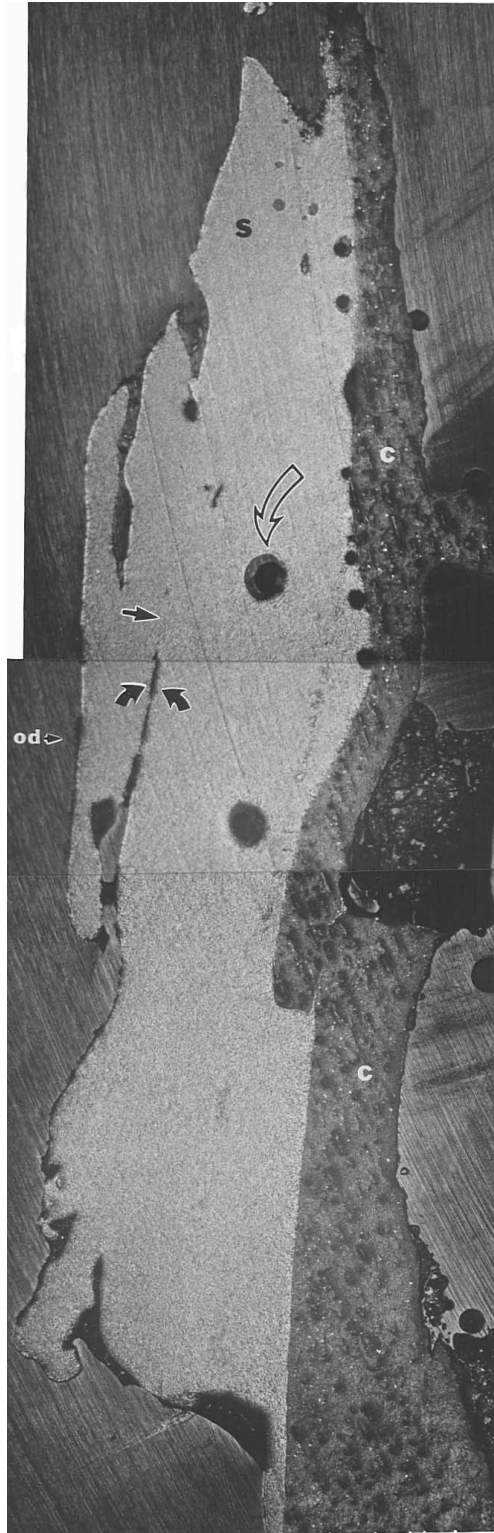
Figure 17 shows a joint, Sample F, that was resoldered in the mid-1970's. Note the dark round shapes indicative of porosity and how the new solder appears from the OD to join a much larger amount of metal than it actually does. At higher magnification, the extent of the lack of fusion is revealed to be even greater than it originally appeared in the lower magnification view, Figure 18. Large regions of porosity and lack of fusion such as this should not be present in a structural joint. The smooth profile of the new joint and solid fill of its solder provides a joint of greater soundness than the material of the resoldered joint. Porosity and lack of fusion represent discrete regions where gaps in the joint exist. The jagged profile of the joint creates sites known as "stress raisers", or places where the stresses the joint experiences are magnified due to geometry. Stress raisers can accelerate joint failure.

What this examination also revealed was a notable difference between a new joint and an older, resoldered joint. The new joint was solid, lacked porosity, and was well fused to the comes. The resoldered joint possessed porosity, lack of fusion, a jagged stress-raising profile, and spotty fusion to a came. All these make the resoldered joint a much weaker construct.

Figure 17: Resoldered joint showing solder(s) containing porosity (curved clear arrow) and lack of fusion (between curved solid arrows). Note that the lack of fusion extends to the small straight arrow above the two curved solid arrows. Original Magnification: 18.75X

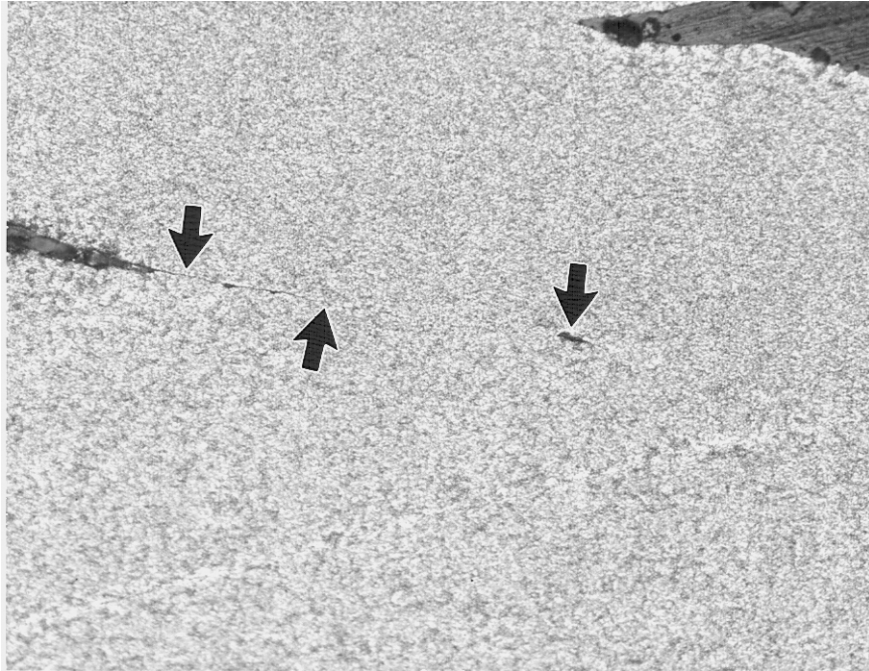
Figure 18: Higher magnification view of lack of fusion in Figure 17, arrows. As-polished. Mag. 100X

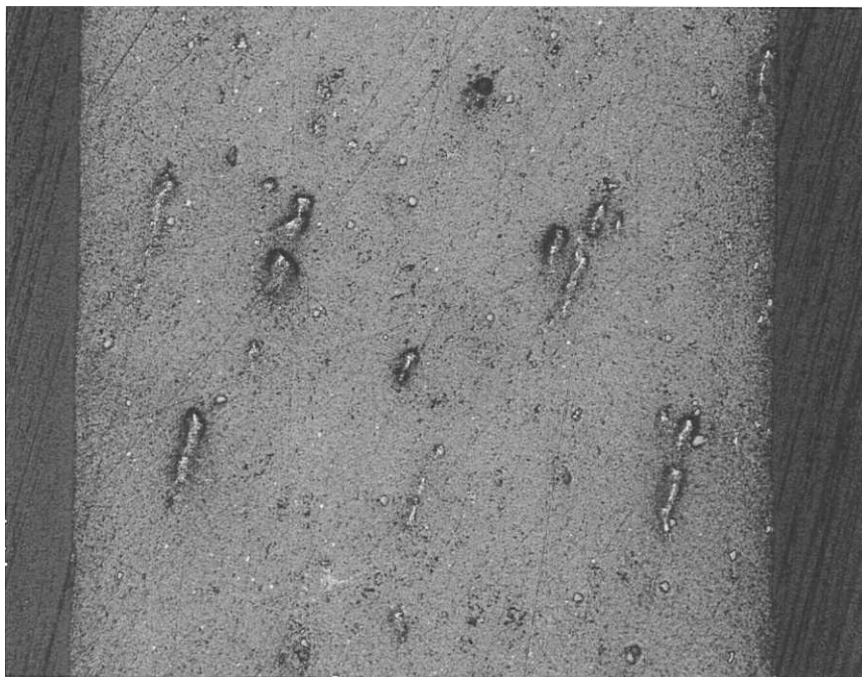
Metallurgical mounts also reveal the depth of any oxide layer present. Figures 19 through 21 show the profiles of the came walls of the new sample, Sample C, and of older comes Samples A and B, respectively. As expected, the new came, shown in Figure 19, possesses no visible oxide layer. Sample A, Figure 20, possesses a well-developed, tightly adhered oxide layer on the came OD. Debris visible on the came ID is caulking remnant. The oxide layer is approximately 0.008-inch thick. Lead is known to produce a protective oxide layer, so this very thin layer is expected and normal, even after approximately 91 years of exposure to air.

Figure 19: New came in cross-section. As-polished. Mag. 120X

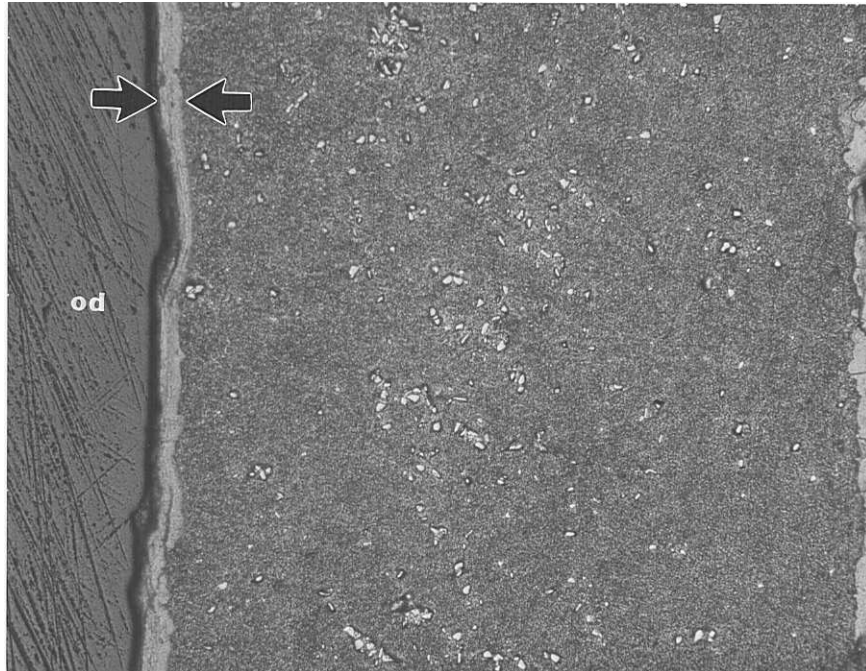
Figure 20: Oxide layer on OD of Sample A, arrows. As-polished. Mag. 150X

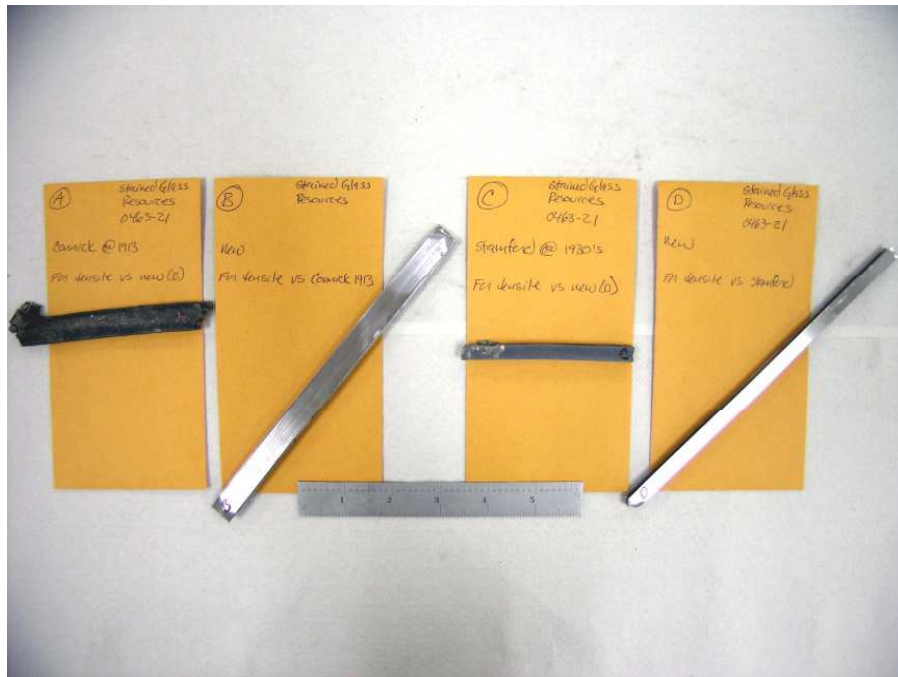
The new came tested were chosen based upon size to compare with older came. This means that one new Sample, *B*, was the same size and configuration came as Sample *A*; and Sample *D* was the same size and configuration as Sample *C*. This is shown in Figure 22. These results indicate that the strength of a new came is a minimum of two and a half times that of an old came. In other words, using a new came provides 250% more tensile strength than the old came. Since the lead came are the structural framework for the glass, this translates into a much greater ability to withstand the weight of the glass and the winds loads to which windows are subjected. This is significant because SEM examination of an older crack fracture surface showed a fracture mode consistent with an overload failure, the same type of failure a tensile test produces.

Figure 22: Comes for tensile testing.
