Restoration Department

The employees of Stained Glass Resources will never forget St. John's Church in Bangor, Maine. For many reasons, the restoration project we performed for St. John's was an extremely chal-

Resources Newsletter is published by:
Stained Glass Resources, Inc.
486 Main Street
P.O. Box 495
Hampden, Massachusetts 01036
Telephone: (413) 566-5053
Fax: (413) 566-2935

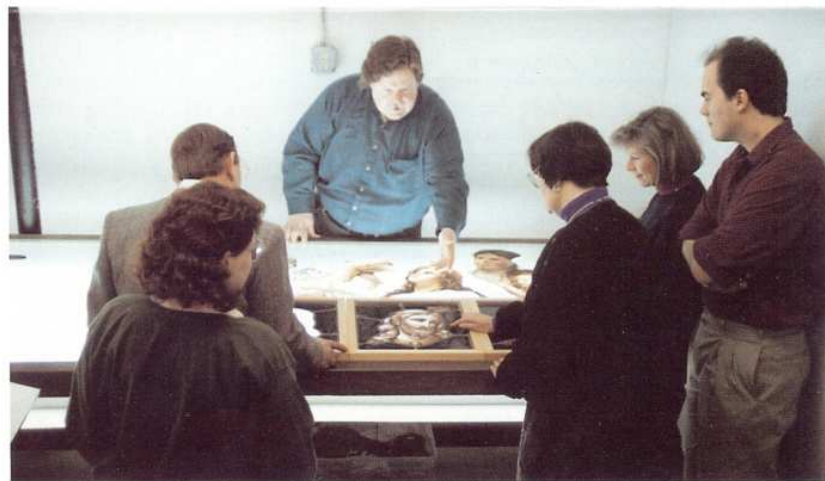
The process of painting and staining is explained during a recent Studio Tour.

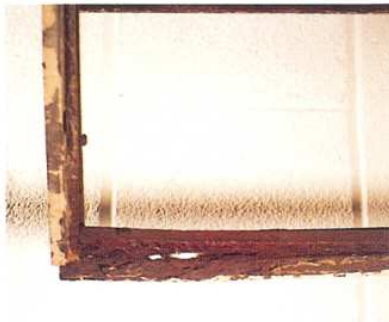
Detail of bottom left corner of inner vent frame prior to restoration.

Problem: Paint Build-up. Years of painting frames causes the layer of paint on the vent to become so thick that it inhibits the smooth operation of the vent.

Problem: Rusted and distorted inner vent frame bottom rail. This is usually caused by breakage in the exterior protective glass, which allows water intrusion and retention in the space between the exterior protective glazing and the stained glass. The resulting rust and rot usually blisters and distorts the bottom rail of the inner vent frame, thus causing it to bind against the outer vent frame.

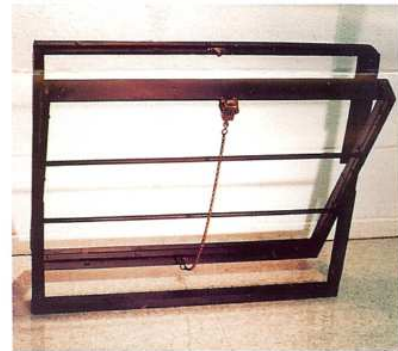
Overall view of frame after complete restoration.

It's important to keep in mind that the vent is both a structural and mechanical part of the stained glass window, and should not be overlooked in a thorough stained glass restoration project. A project that does not include proper vent restoration is not complete, and will lead to additional expenditures in the near future when difficulties in vent operation lead to damage of recently restored stained glass.

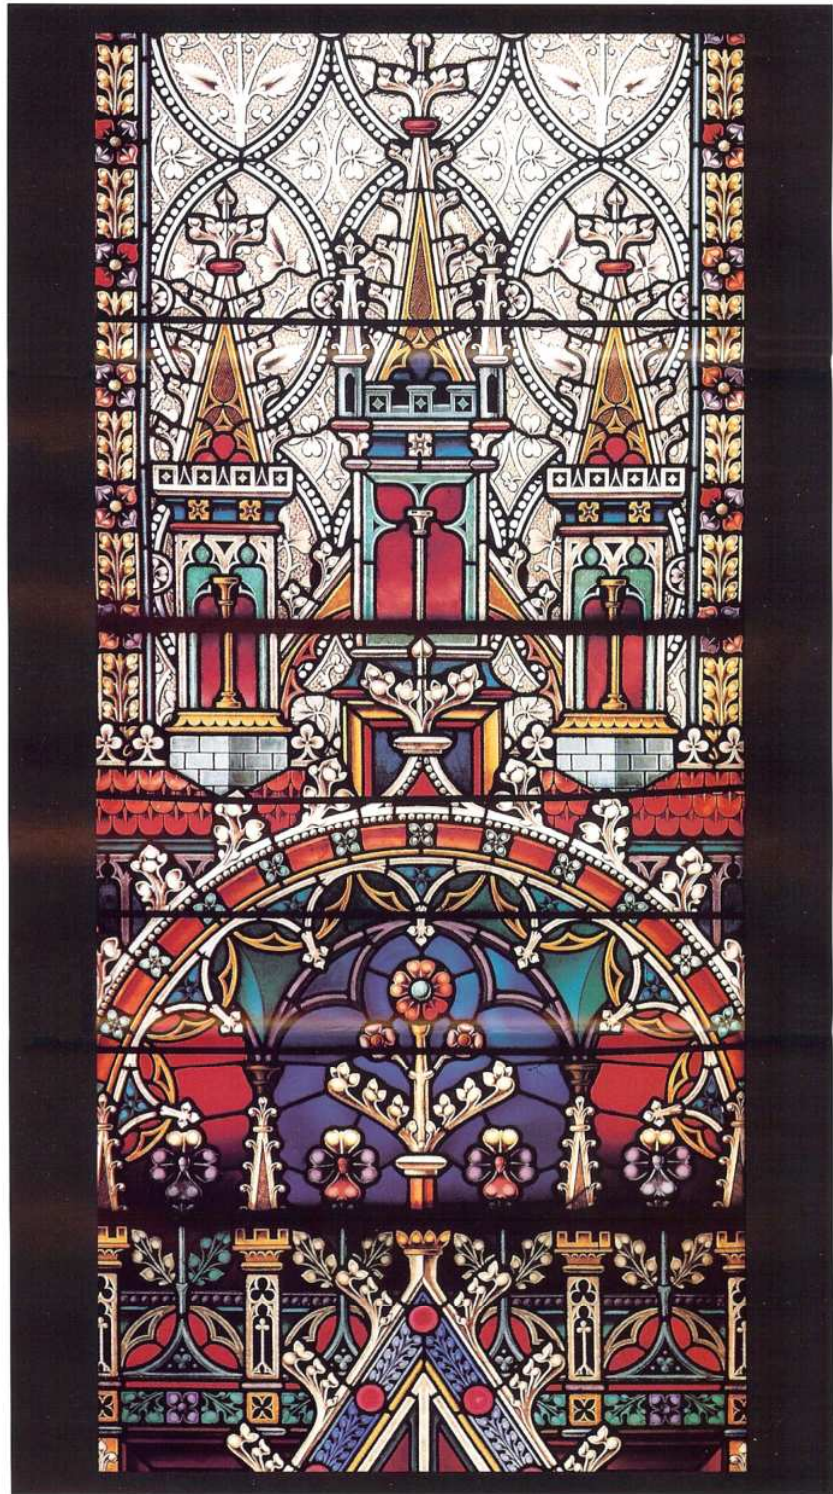
Detail of typical triple canopy - St. John's Church, Bangor, Maine

History: The windows at St. John's Church in Bangor, Maine are without a doubt some of the largest ornate windows that we have restored. They are uniquely ornate due to the fact that extremely fine painting and staining techniques were used, in addition to very fine leading, to further delineate the details of the design. They are from a period of realism in stained glass history most commonly referred to as "The Munich Style". They were designed by Franz Xaver Pernlochner between 1885 and 1888. Born in North Tyrol, Austria in 1847, Pernlochner was a student of F. Plattner,

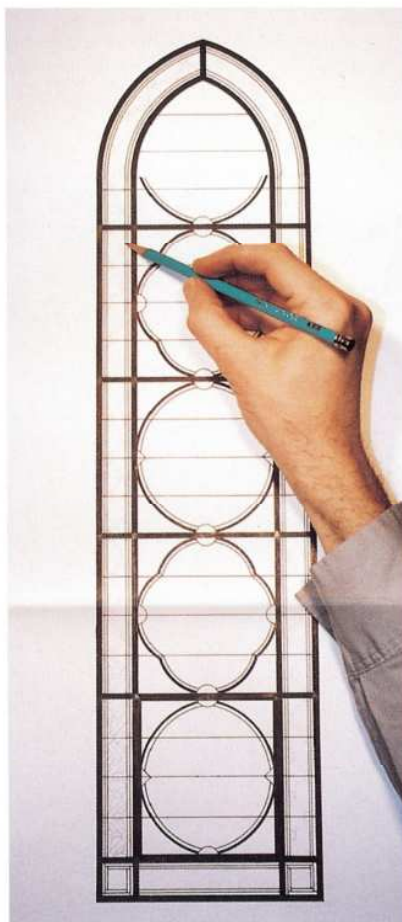
Structural Layout – Beginning of sketch

panels. Within these sections horizontal bars are added for support. The pattern of lead lines is drawn with consideration for stress within the section. Our experience with restoration of older windows teaches us a lot about bowing and buckling of windows, often the result of sections built too large, with insufficient support bars or with poor placement of lead lines.

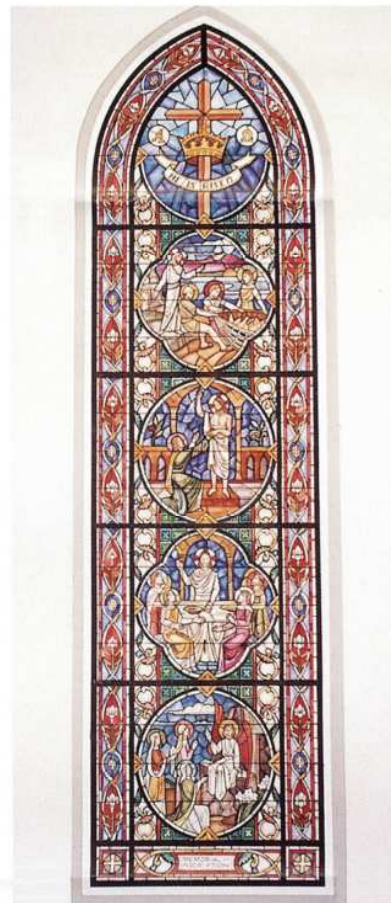
A completed sketch

The challenge for a stained glass artist is to bring together many factors into a sketch that creates an effect that is beautiful and meaningful. It must also be a plan for making a structurally sound window. Only then can work begin with glass and lead.
