PUBLISHED BY STAINED GLASS RESOURCES, INC.

A Newsletter Dedicated to Providing Educational Information About Stained Glass Restoration, New Design & Fabrication

Do Your Windows Need Attention? Do You Know What To Look For?

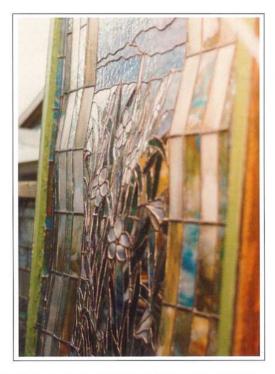
Are your windows bowing, buckling or bulging? This is known as planar deflection and is an indication that the lead channel, which is the primary structural support system of the window, is deteriorating. Depending upon its alloy composition, lead has a service life of 75 to 100 years. If your windows are nearing this age, it is time to call and request a window survey and condition report. If the deflection is allowed to progress, the window will migrate downward, tear away from the support bars and, eventually glass will break as a result of this stress. All three of these photographs show

windows that have been allowed to deteriorate to the point of structural failure. Responsible maintenance calls for intervention before this level of deterioration occurs. The panel in the upper right photo is just starting to deflect from its original vertical plane. The stained glass window in the lower left corner has severe deflection to the point of structural failure of the lead. The panel in the lower right corner has a severe buckle, and has completely detached from one of its horizontal steel support bars. All of these panels are in need of restoration.

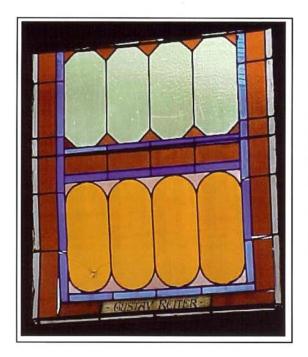
An easy condition to spot is the appearance of light leaks between the glass and the lead. This is an indication that the lead has aged and stretched over time and is allowing the glass to displace from the lead channel. This condition can quickly result in the loss of the most important part of the window - the stained glass. It can also endanger people walking or sitting near the window. The window on the upper left has relatively small, but clearly visible light leaks. A good rule of thumb is that if the edge of the glass is visible (as in the lower left photo), the window needs attention immediately. The window below on the right has suffered complete structural failure. The topmost section (peak) has torn loose from its steel reinforcing bars and the entire top panel has fallen down between the stained glass and the exterior protective overglaze. The inset photo is a view of the same window from the interior. The overglaze actually saved this panel from being completely destroyed.

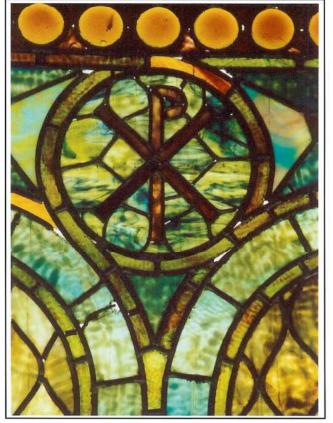
Below: This window was cemented in place and could not be properly cleaned or inspected. In some areas the glass is entirely obscured by the gray cement compound.

Above: Although complete lead replacement was properly prescribed for this window, the restoration studio was not closely examined. The poor quality of this work is hard to believe. Lead miters are non-existent, the soldering is not completed, holes from broken glass are left gaping, and it appears that no glass was cleaned. This window was severely damaged by a misguided, unskilled craftsman. Again, knowing when to call and knowing whom to call will both dramatically affect the life of your windows.
