Editorial Statement

Restoration Department

Studio Project

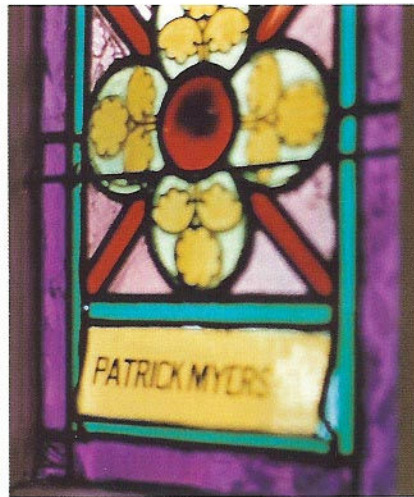
Buckling is so severe in this window, that the dedication plate is falling out.

1. Check for bowing and buckling: when looking up the vertical plane of the window towards the peak, are there areas

that are not flat? Do you detect concave or convex bulging? Many times we have been asked if bulging is a natural occurrence in the window and not cause for concern. The answer is that although it is natural for it to occur, it is a symptom of structural failure and advanced deterioration, which will cause glass breakage, resulting in a more costly restoration.

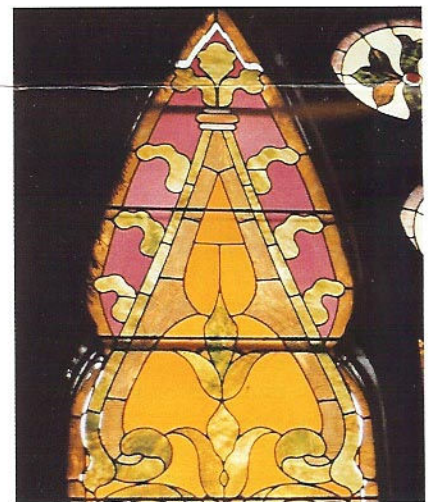
Lead deterioration is extremely advanced in this window. Notice the separation between the lead and the glass in the outer border at the top of the window.

3. View the condition of the lead channel between the pieces of glass: this channel is responsible for holding the glass pieces together and is the structural backbone or "skeleton" of the window. Look for broken, cracked, peeled back, or deformed lead channel.

5. View the window for areas of daylight that may occur between the lead channel and glass: this results from the deterioration of the structural support system. It is often noticeable in areas of large bulges and sometimes even in areas where the window is still flat. It results from the movement of

the window which then causes the weakened lead channel to pull away from the glass. Also, daylight can often be seen at the top of the window as a result of the entire window sagging downward towards the sill.

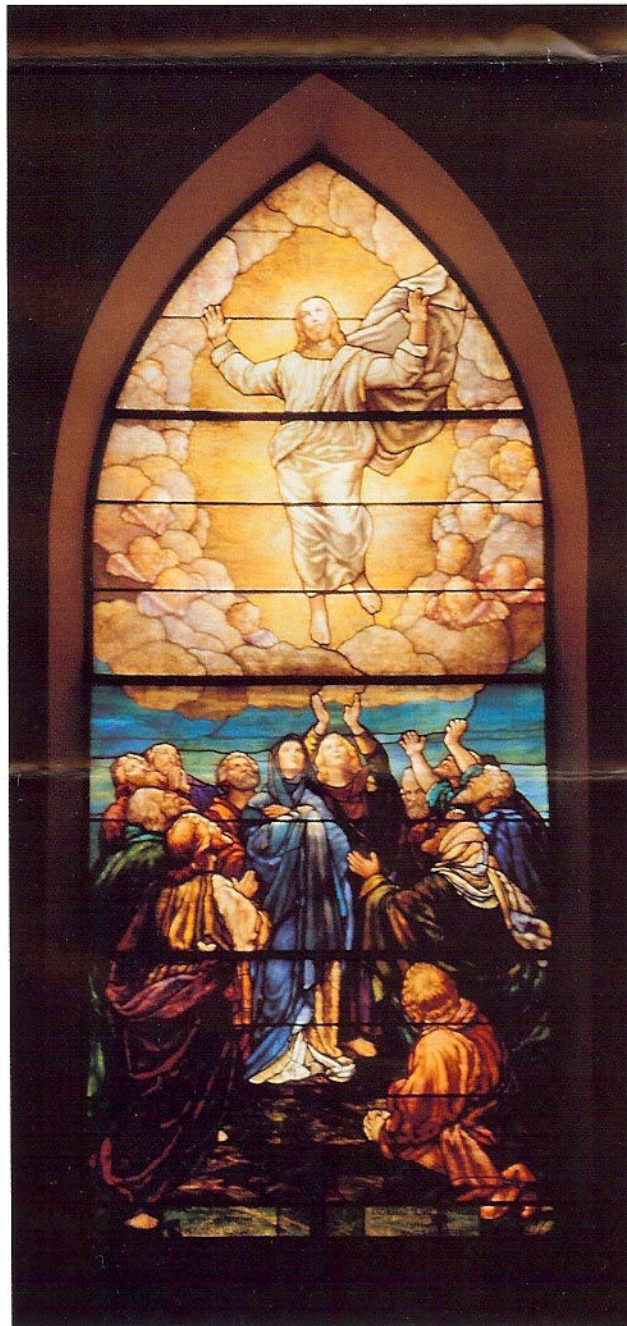
**Ascension Window—
St. George's Church,
Lee, Massachusetts**

The second window restored was a memorial window dedicated in memory of Katherine Henry Washburn by her daughter Mary S. Baird on March 30, 1910. The subject is the Ascension and represents Christ rising up into the clouds while adoring disciples and women gaze up at him from below. This window is particularly large for a plated window. It is over thirteen feet tall and is six feet wide.

were removed had indicated that new protective overglaze should be installed on both windows. This was due to the fact that the old overglaze was insufficient, broken, and leaking. The examination had also uncovered extensive sill deterioration in the Ascension window frame. We performed this work in coordination with the reinstallation of the stained glass windows.

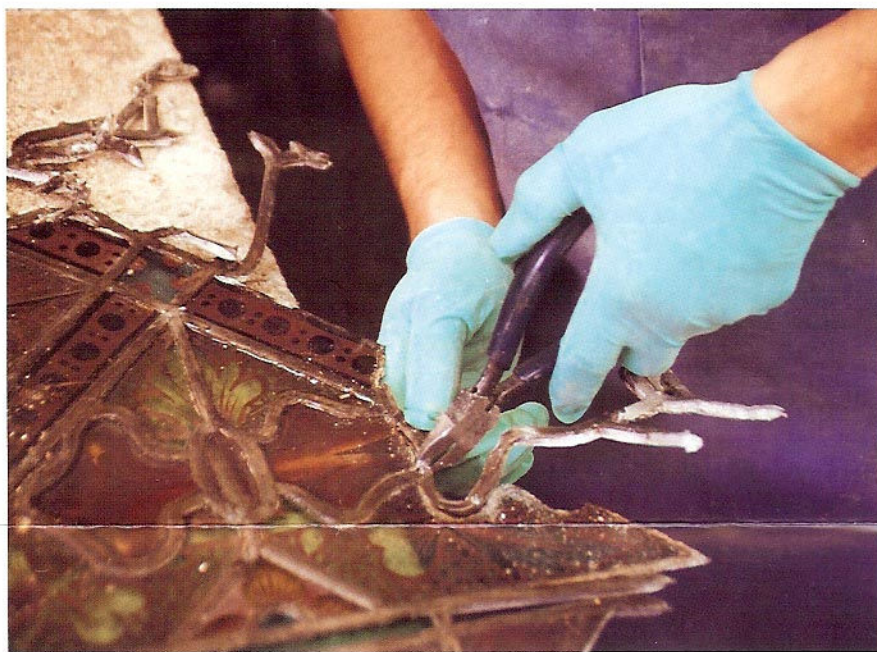
Disassembly Process

The first step after the window has been removed and brought to the shop is to: 1) view it in the light in order to make notes regarding: previous repairs which had resulted in improper glass replacement, badly faded painted glass, etc.; 2) photograph the

Once the window has been disassembled, any broken pieces of glass are reviewed, and determinations are made as to their replacement or conservation. Replacement, repair, conservation, etc., are then performed, and the window is then ready for releading.

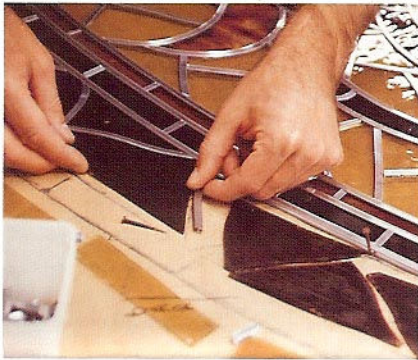
Assembly Process

channel. When the window has been reassembled, it is checked for sizing, and then prepared for soldering. The solder, usually a 60/40 mixture of tin and lead, is then applied to each joint where the lead abuts. After the first side of the window is soldered, it is thoroughly cleaned to remove any flux residue. The soldering and cleaning process is then repeated on the back side.

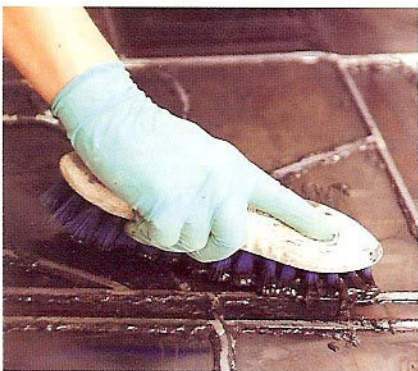
Cementing Process (Waterproofing)

After the cement has been allowed to cure for a few days, the window is ready to undergo final inspection and cleaning. The window is once again viewed in the light so that it can be properly inspected and thoroughly cleaned.

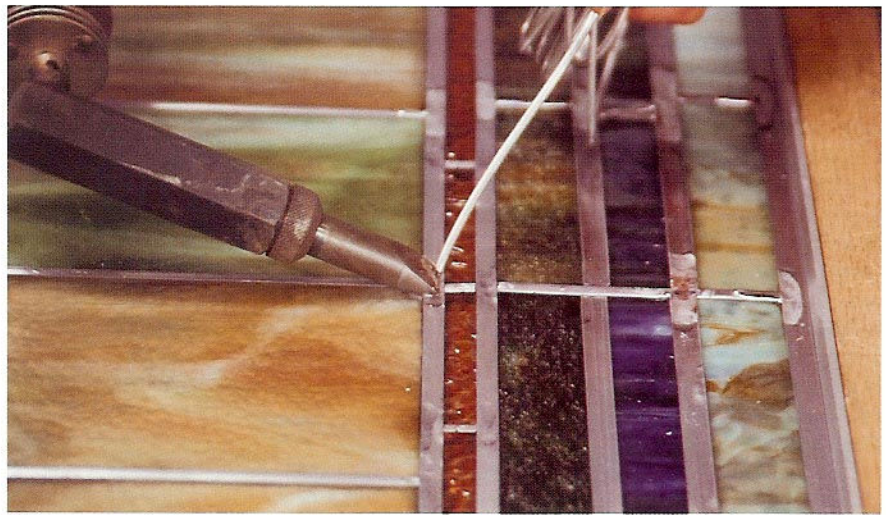
Soldering Process

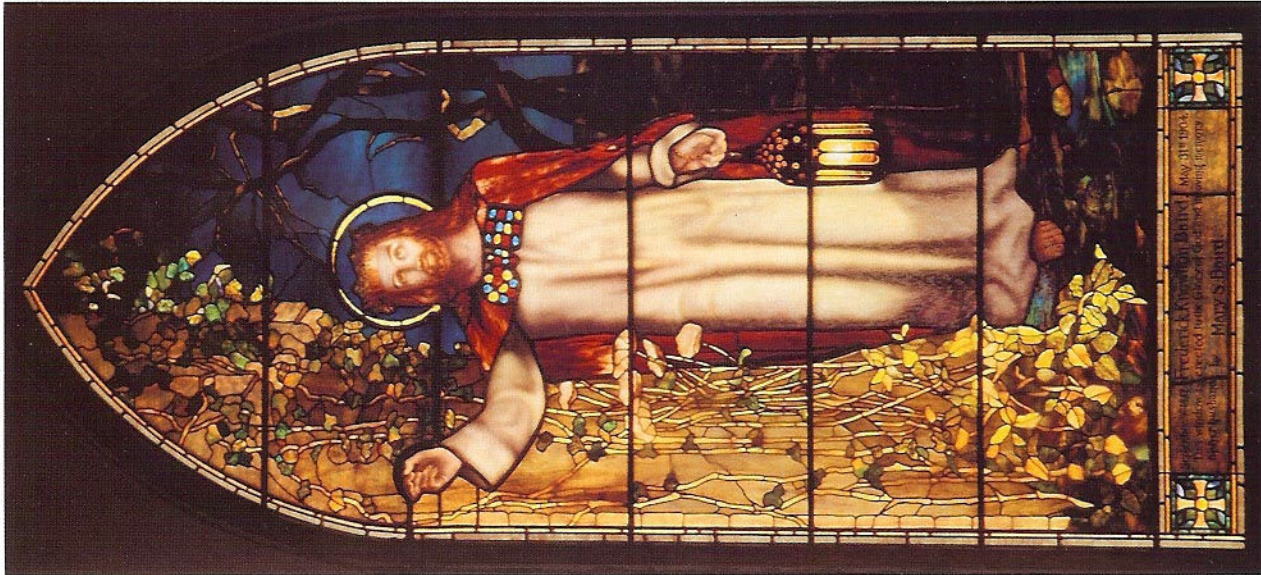
“Christ Knocking at the Door” —
 St. George's Church, Lee, Massachusetts

The first window restored was a memorial window dedicated in memory of Frederick Knowlton Baird by his wife Mary S. Baird on August 11, 1909. It is a copy of the Holman Hunt painting "I Stand at the Door and Knock". It represents the figure of Christ clad in a white tunic with a cloak of deep red over the shoulders, one hand holding a lantern, the other knocking at the door. The radiance shed from the lantern is brilliant—a result of the superb combining of acid etching, silver staining, and trace-line painting.
